Home Inspection Report

FOR THE PROPERTY AT:
123 Sample St
Mocktown, NS

INSPECTION DATE:
Saturday, December 24, 2016

RE: Report No. 1135, v.0
123 Sample St
Mocktown, NS

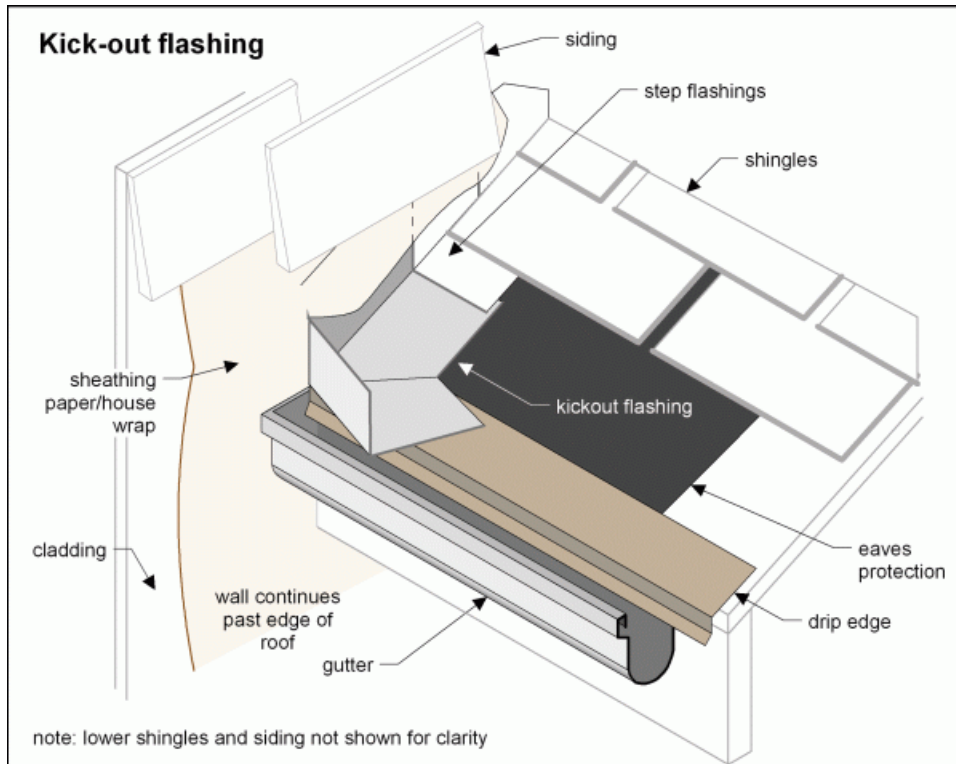
gutter issues

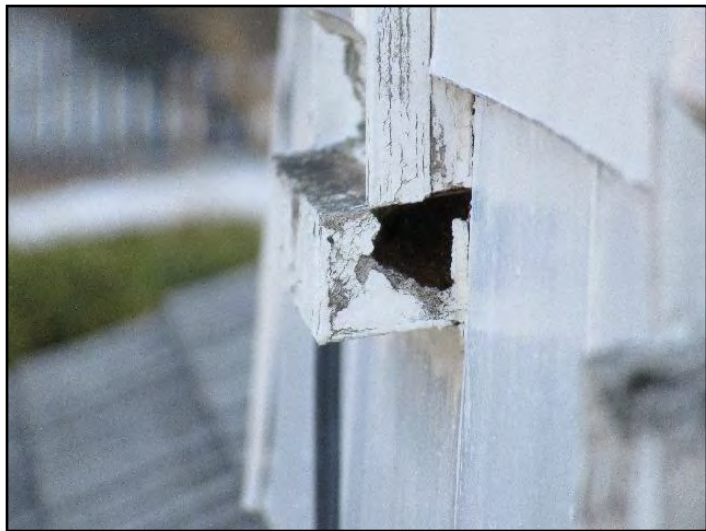
rotted window sill/nosing

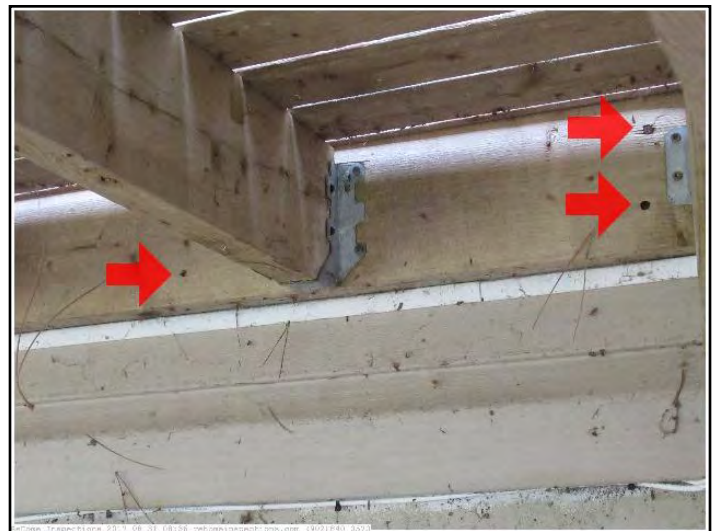
rear deck

Condition: • [Inadequate ledger board fastening; not to current standards](#)

* The ledgerboard was secured with nails and placed directly over the siding without appropriate flashing. Water will be able to penetrate behind ledgerboard and may find its way into the wall cavity via the unsealed penetrations created by the nails. Recommend to remove structure and re-attach accordingly (removing a portion of siding, flashing on the ledgerboard, and attaching with lag bolts).

Task: Improve

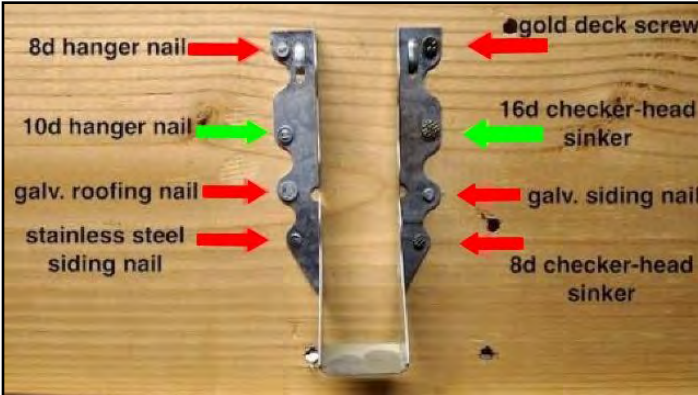
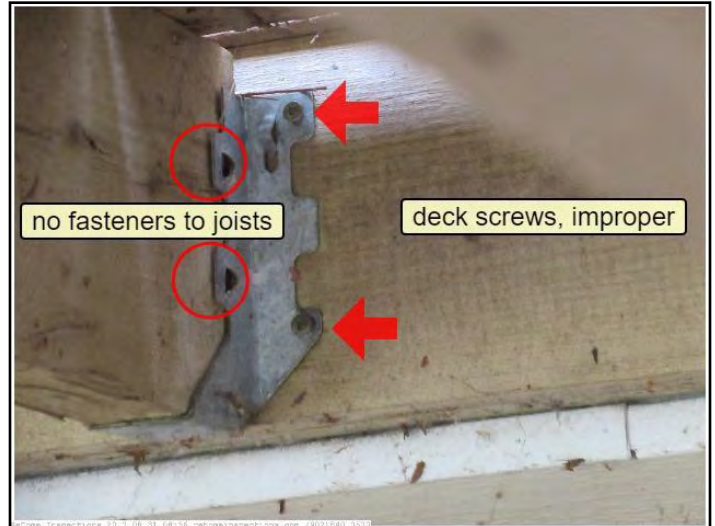
Condition: • [Improper joist hanger fasteners used](#)

It is important to understand two structural forces exerted on fasteners: withdrawal and shear. Screws are better than nails at resisting withdrawal - it is much easier to pull a nail straight out. However, when it comes to joist hangers the shear strength of fasteners is much more important; and only proper nails (aside from a few rarely used structural bolts or specialty screws) can provide the recommended strength to resist this perpendicular force and support a heavy load as is often found on decks.

Deck screws and roof shingle nails are often used; this is a defect. Specially designed galvanized joist hanger nails (often

Task: Correct

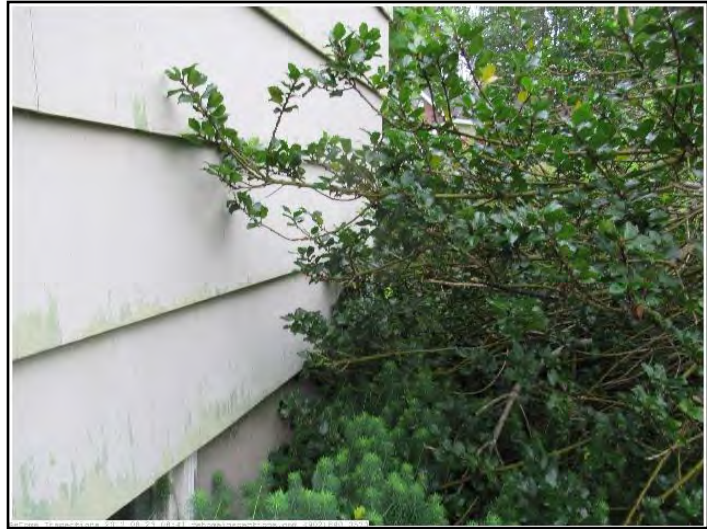
west

Condition: • Plants too close to building

Trees and shrubs add aesthetic appeal to a home, but can cause damage to exterior components. Vegetation in contact with the home provides an access path for wood destroying insects, promotes moisture against the walls, and may cause physical (mechanical) damage. All vegetation should be cut back away from the home a minimum of 6". Leaves falling from overhanging tree branches can clog gutters, while the roots of larger trees can damage drain pipes and crack foundations.

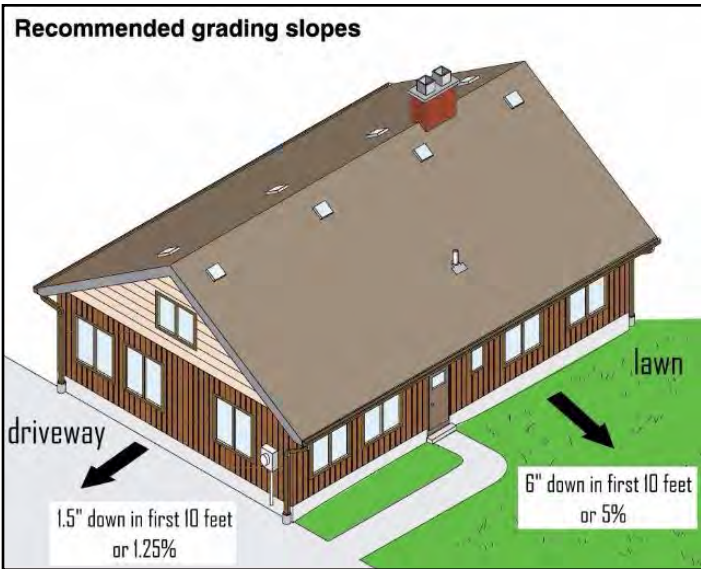
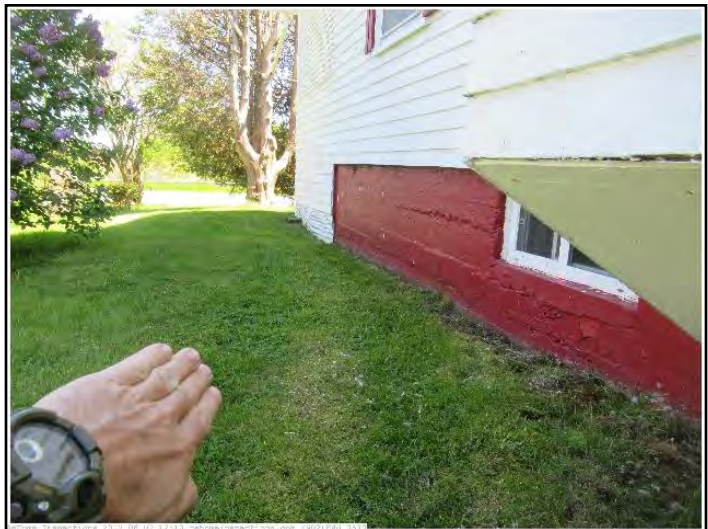
Condition: • Improper lot slope or drainage

This can cause pooling of water adjacent to the foundation which can lead to water entry into the basement and damage to building materials. The lot should be sloped at a minimum 5% drop away from the foundation (6" drop in the first 10'). For harder and less porous materials, such as concrete or asphalt, this slope can be reduced to about 1.25% (or a 1.5" drop over 10'). The goal is always to direct and divert water away from the foundation. Be mindful if re-grading that adequate clearance to the siding be maintained (6" minimum). If this clearance cannot be maintained a simple swale (small ditch) or french drain can help to divert water away.

Task: Improve

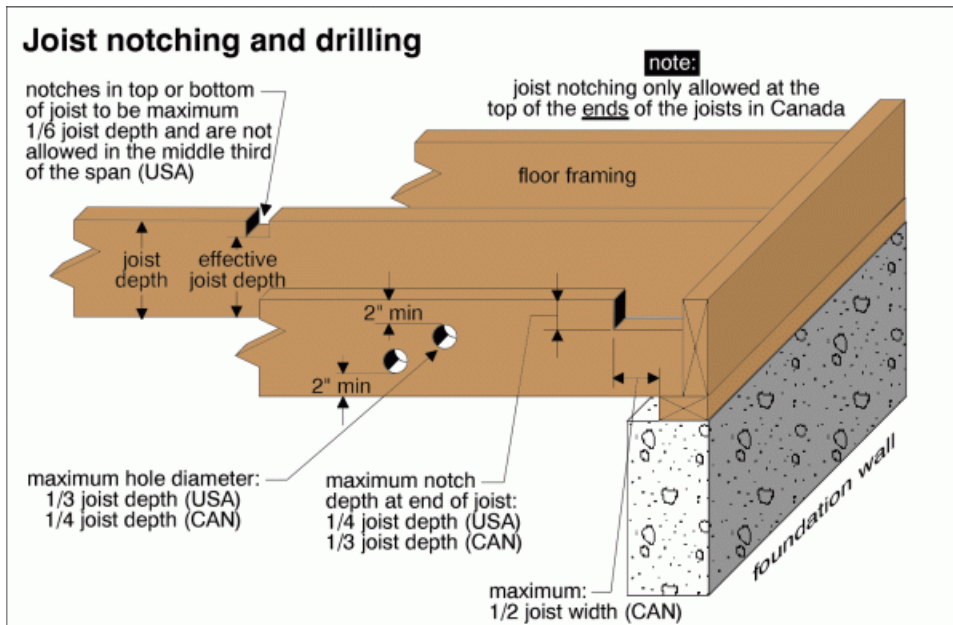
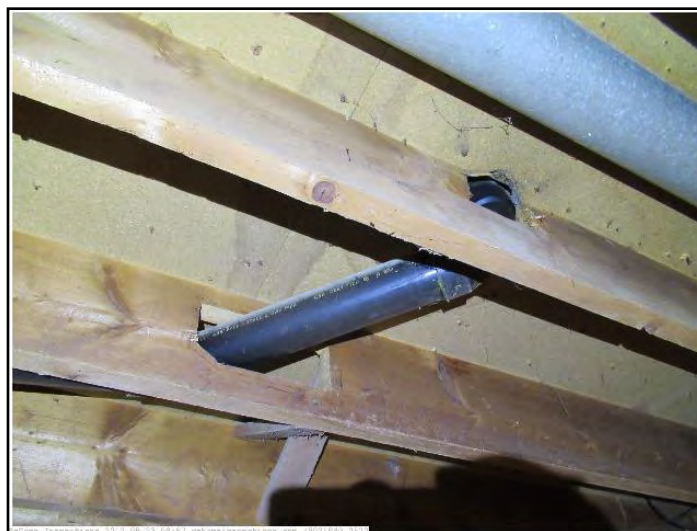
Condition: • Joists have been improperly notched and holed; this has significantly affected the structural integrity. Several of these joists are in need of additional support underneath to create a structurally sound floor. I recommend to consult

Task: Correct

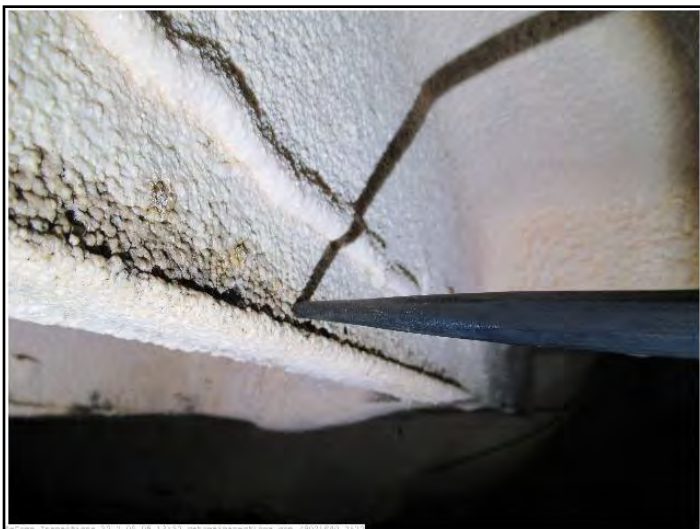
rotted behind spray-foam

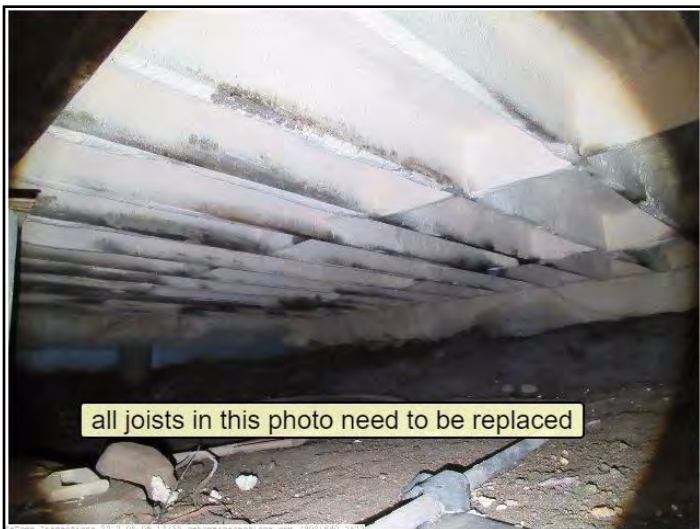
all joists in this photo need to be replaced

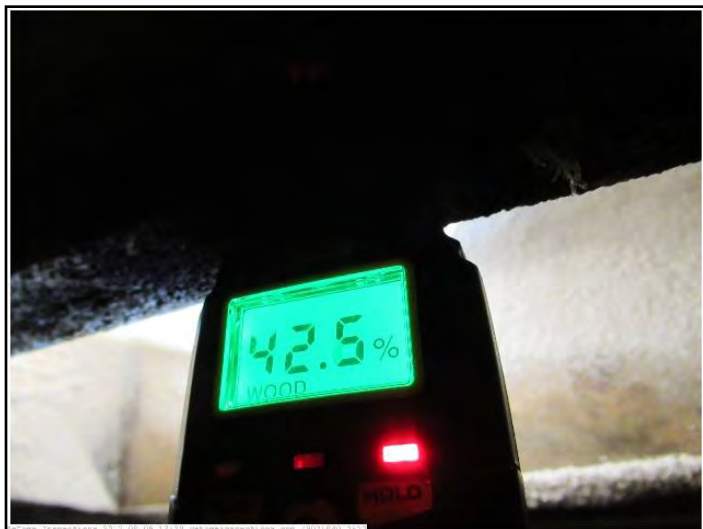
very high moisture, wet

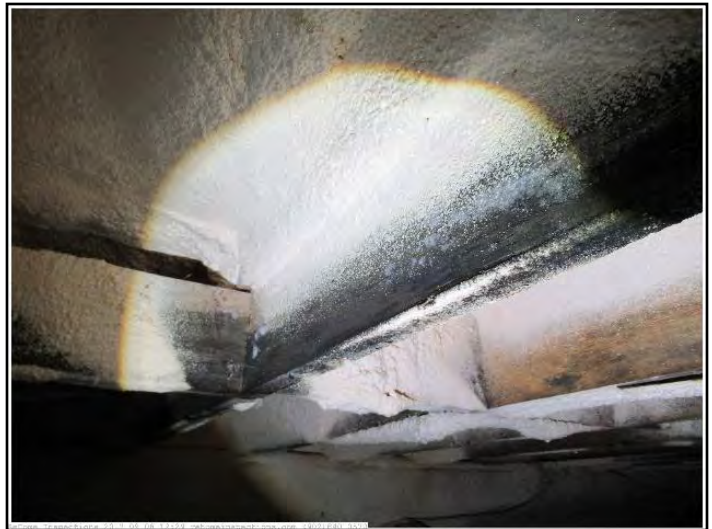
rotted/wet

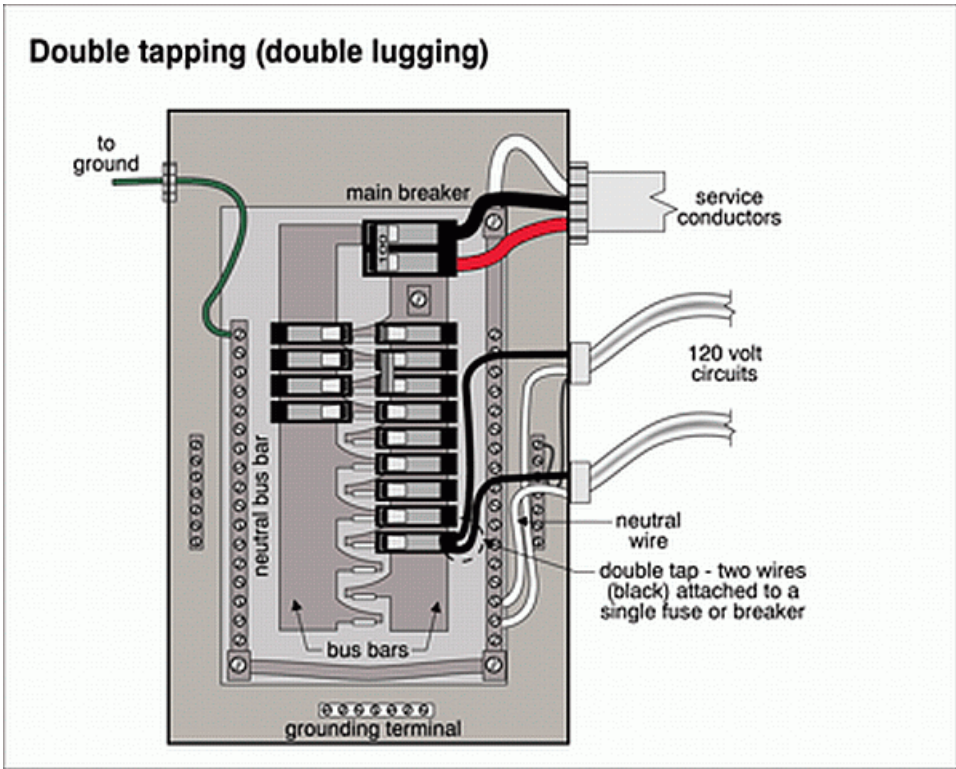
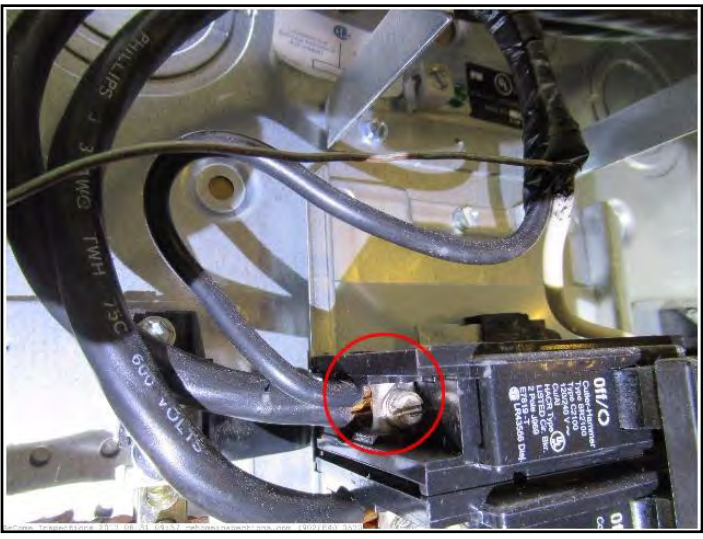
Condition: • [Double taps](#)

There is a breaker that has two wires attached - this is referred to as a 'double-tap'; this can cause loose connections which can lead to arcing and a potential fire. This wire, I suspect, is the underground wire used to feed the garage. It is attached to the main 100-amp breaker disconnect. I recommend this be corrected by a qualified electrician; this wire should be on its own individual circuit breaker - and there are still empty slots available for additional breakers/circuits.

double-tap

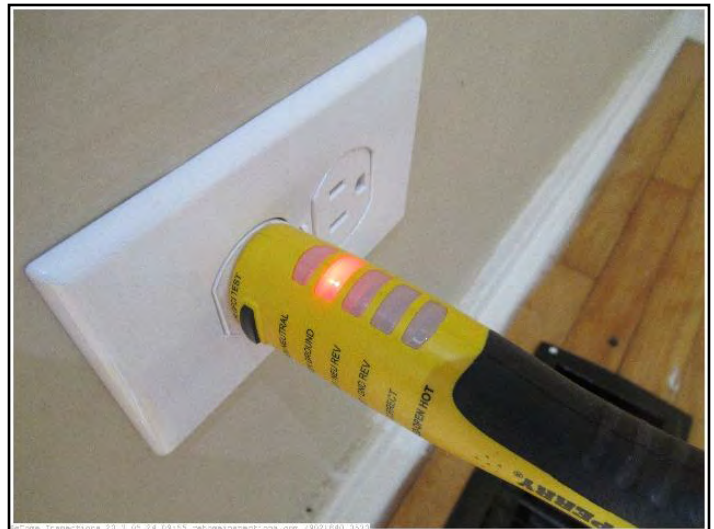
ungrounded - incorrect

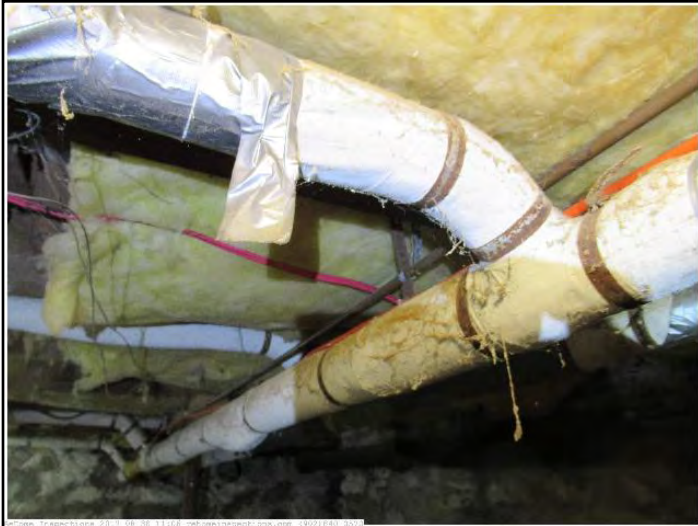
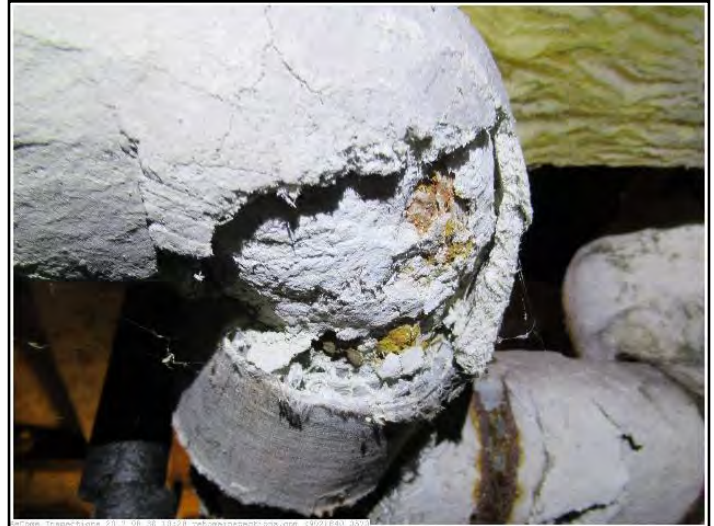
deteriorated, friable

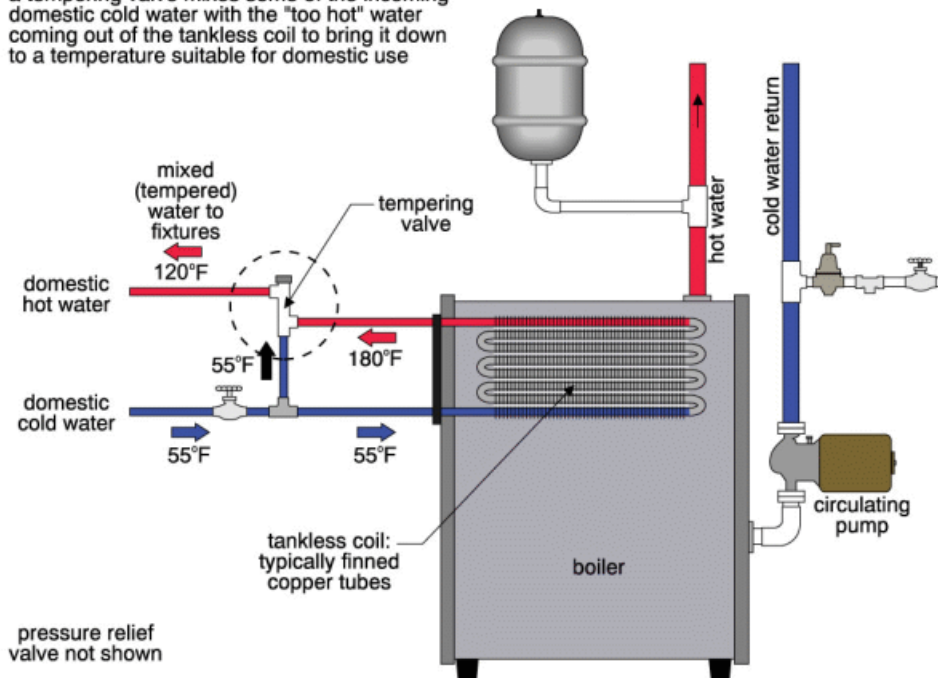
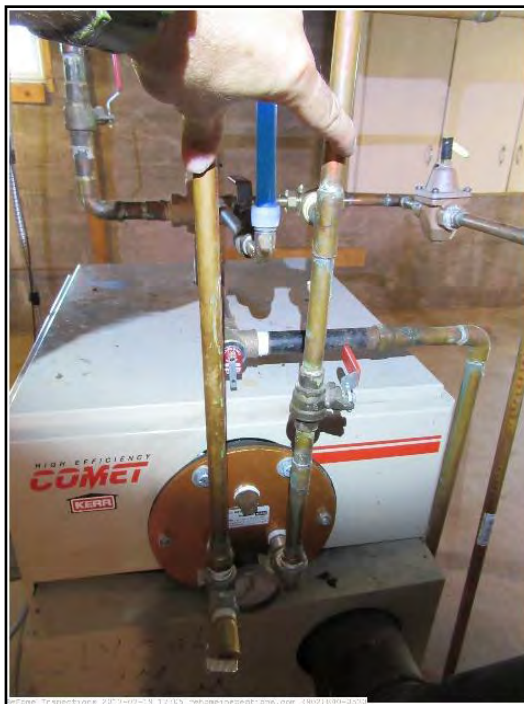
tempering valve missing

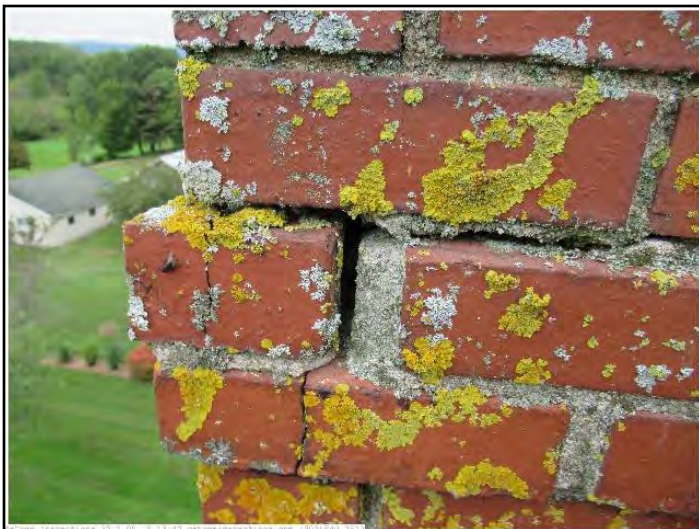
deteriorated

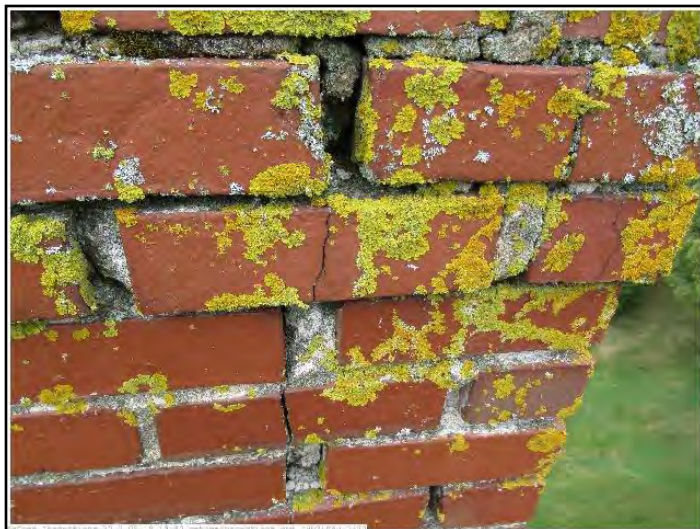
deteriorated

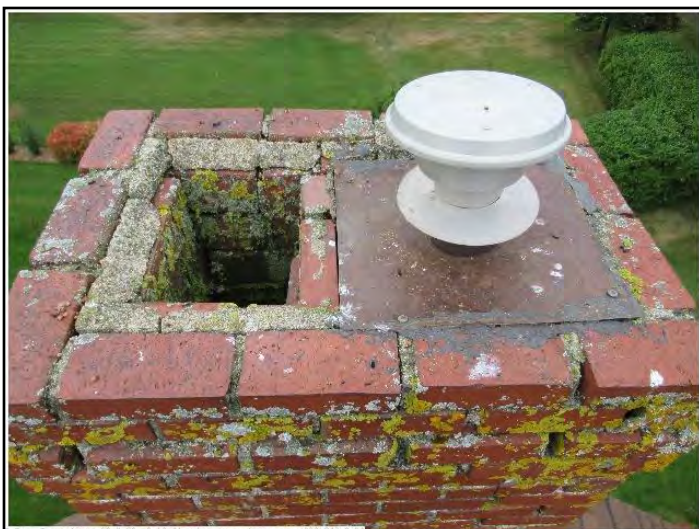
missing cap

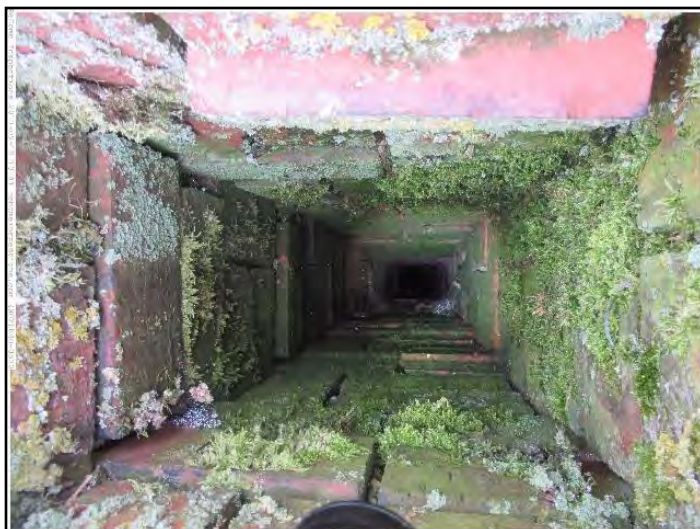
missing liner

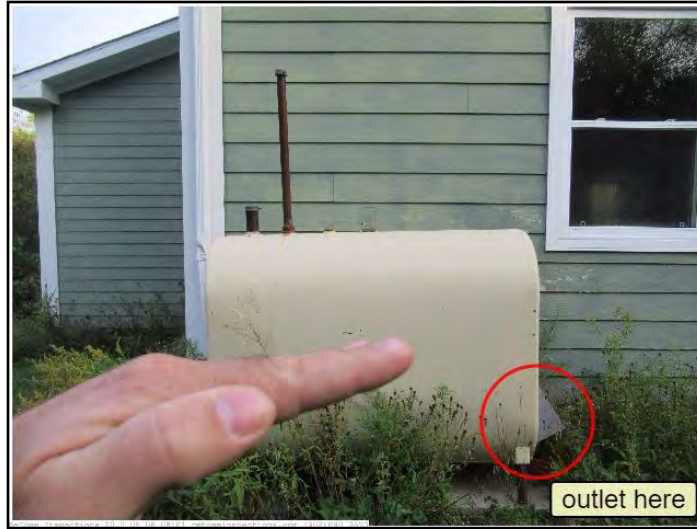
Condition: • The oil tank is sloped in the wrong direction. It is recommended to have these tanks sloped downwards towards the outlet side by at least 1/4" per foot. There is good reason for this: water is heavier than oil and will sit at the bottom of the tank. Water can be introduced into tanks many ways; through condensation or even water that is mixed in with the oil itself at delivery time. With the negative slope the water can pool and remain in the tank, rusting it from the inside out. I recommend to correct the slope of this tank. Tip: keeping the tank topped up helps to reduce the likelihood of condensation forming.

oil tank incorrect slope

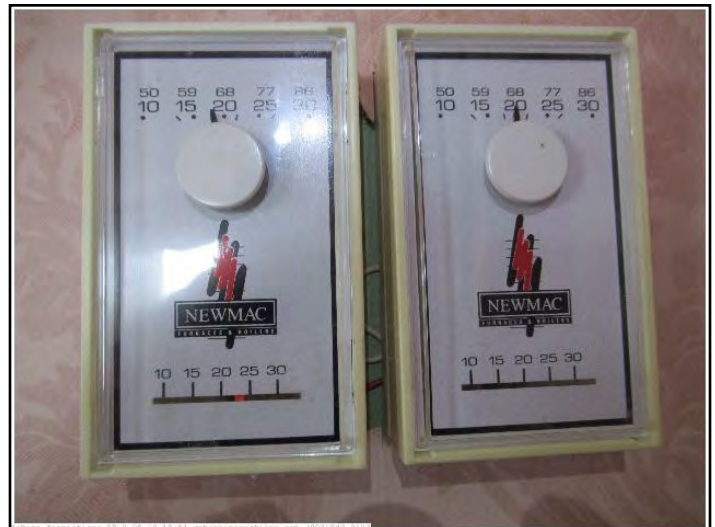
dining room

Condition: • Unprogrammable thermostat installed

Consider installing a programmable thermostat; it allows you to schedule automatic increases and decreases in your homes temperature. Theyre easy to install and easy to use, especially if you keep a fairly routine schedule. Just program the thermostat to drop a few degrees at night while youre sleeping or off at work during the day, and set it to return to your preferred temperature just before you wake up or return home from work. You wont notice the difference - until you see your lower utility bill.

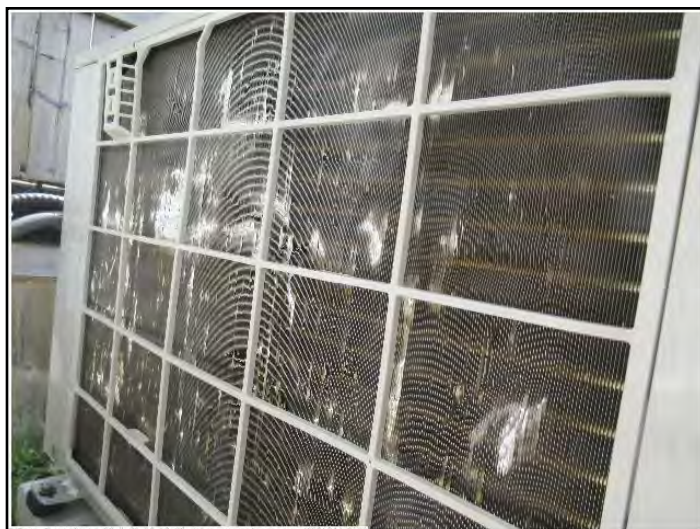
fins damaged

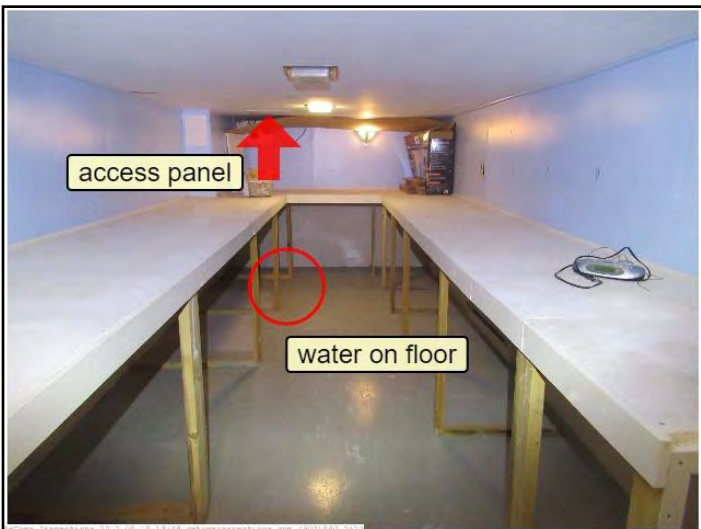
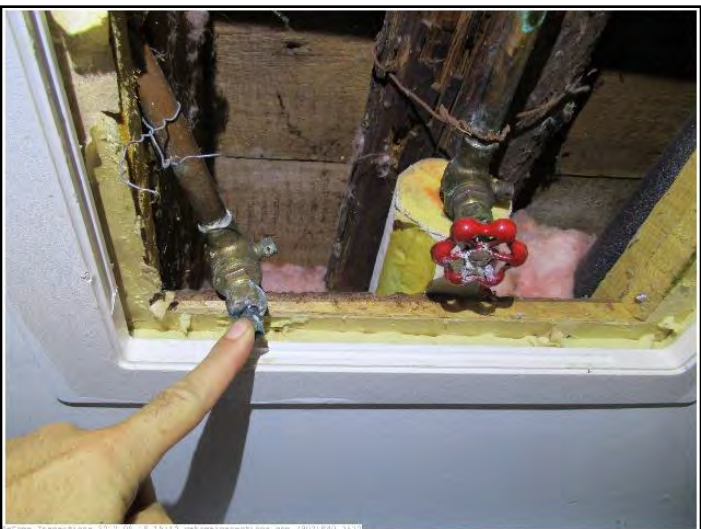
leaky valve

Task: Repair

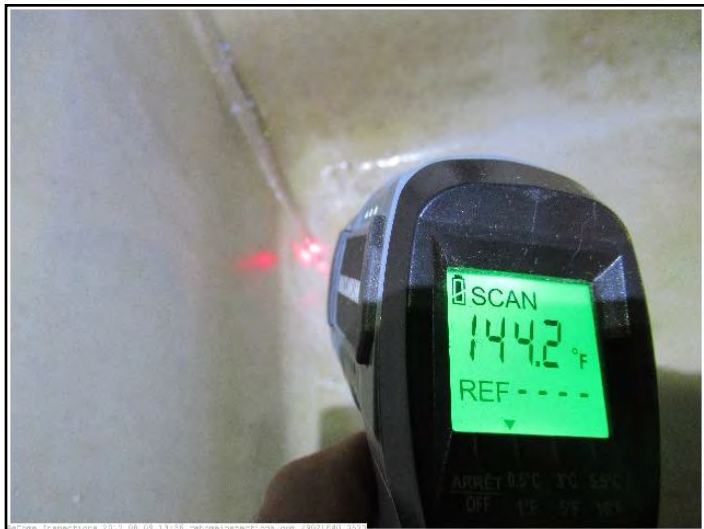
Kitchen sink - HOT!

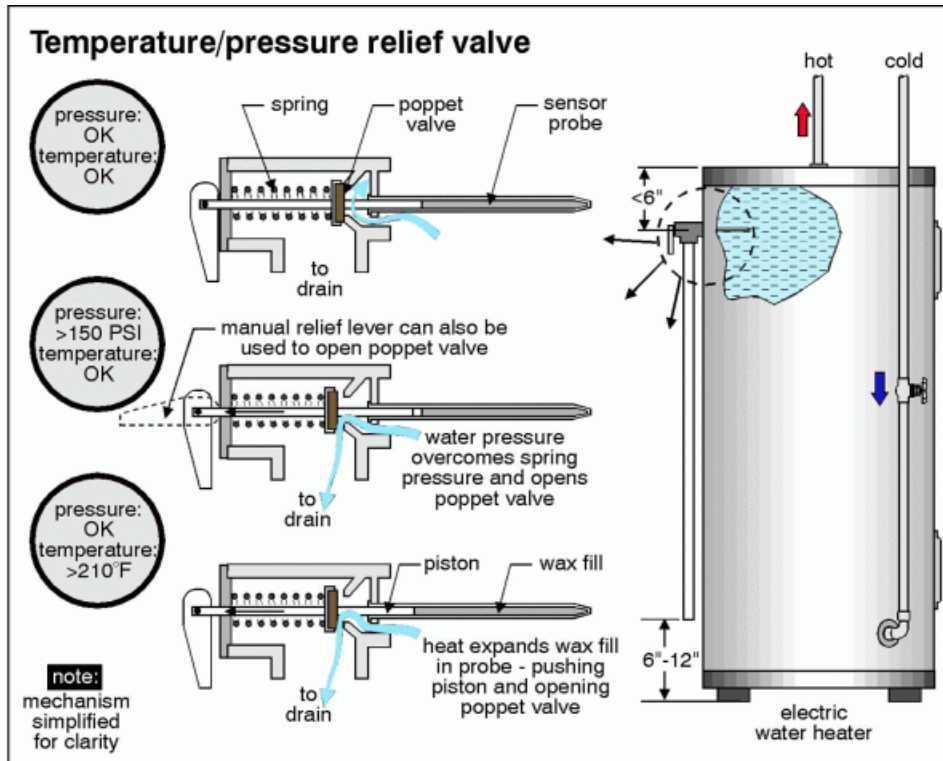
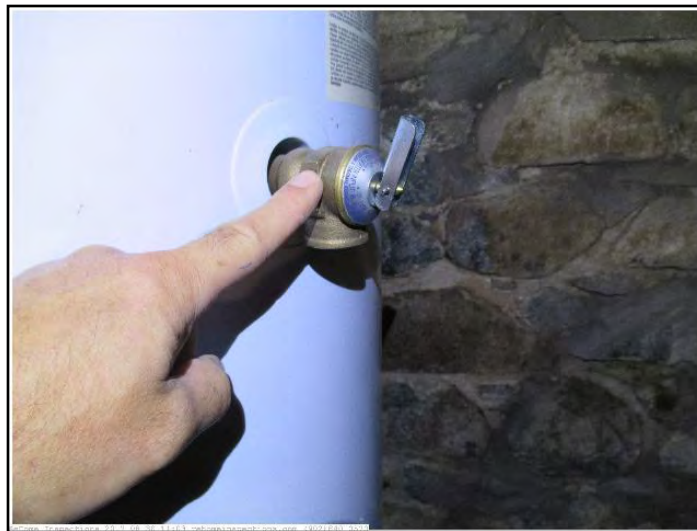
TPRV discharge tube missing

Task: Provide

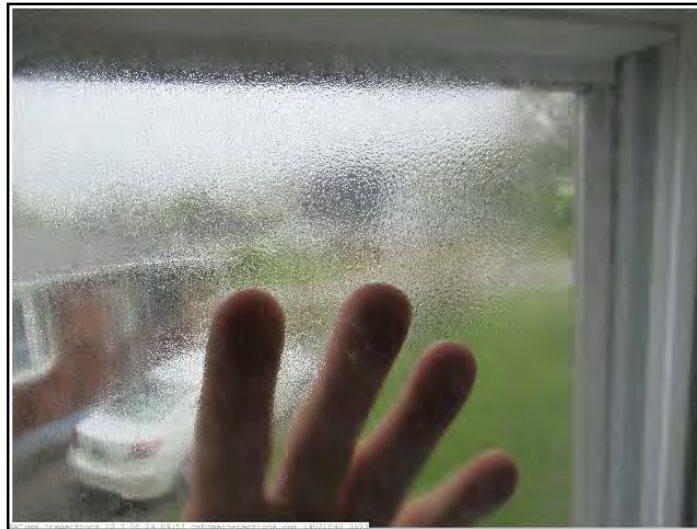
broken window seal

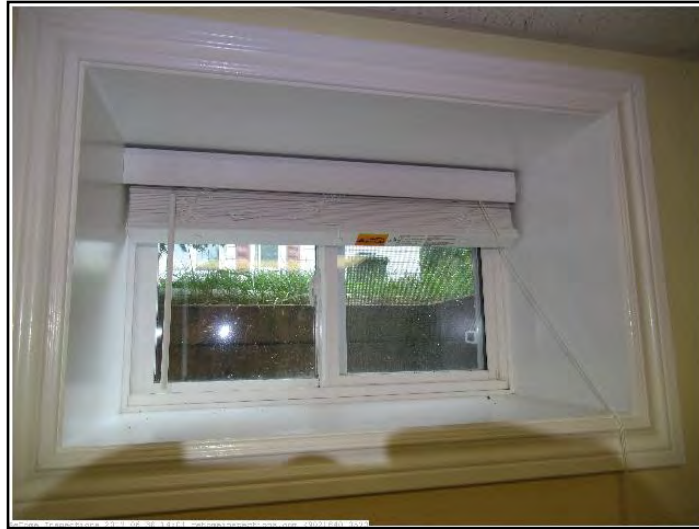
inadequate egress in basement bedroom

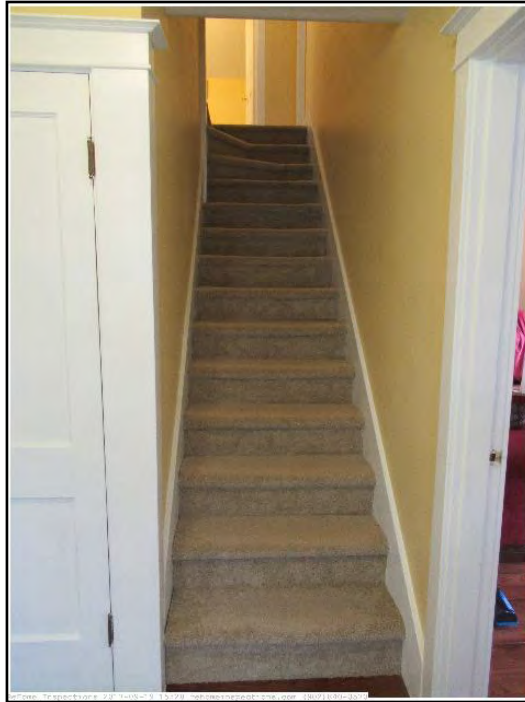
missing handrails

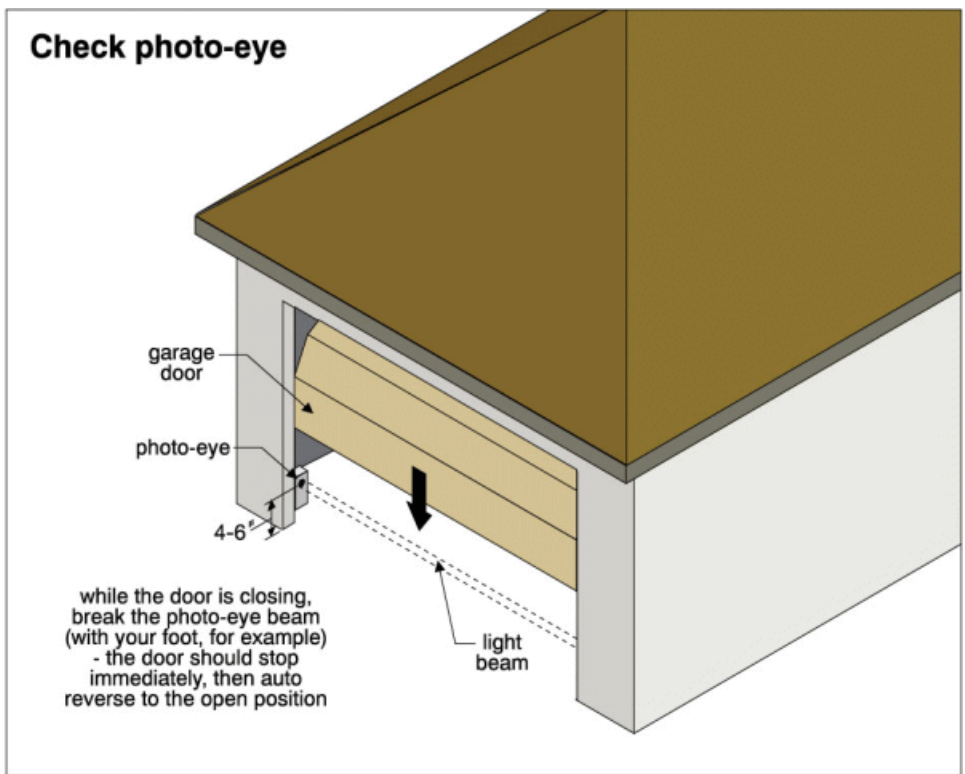
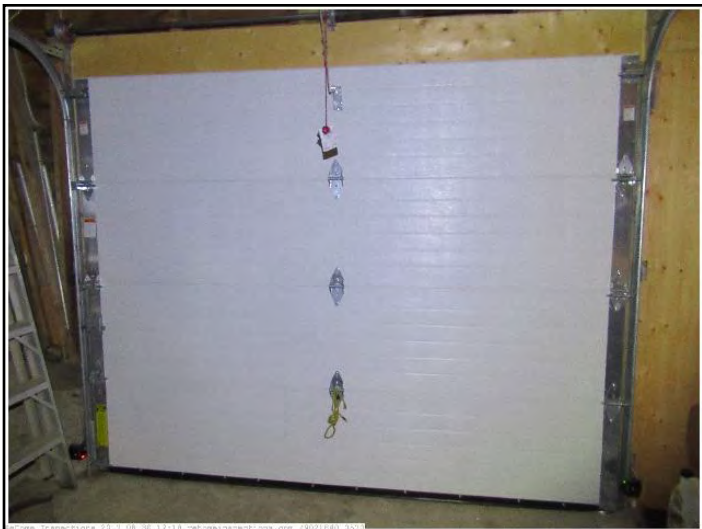
Condition: • [Fails to auto reverse](#)

Garage door properly auto-reversed when the photo-eye sensor was tripped but failed to auto-reverse when sensing resistance. I recommend to adjust the sensitivity of the resistance setting which can be done via buttons on the underside of the motor. Also, I recommend to remove the manual door lock - when an automatic garage opener is installed major damage can occur if the door has the lock engaged and someone tries to open it via the automatic motor.

fails to auto-reverse

Task: Correct

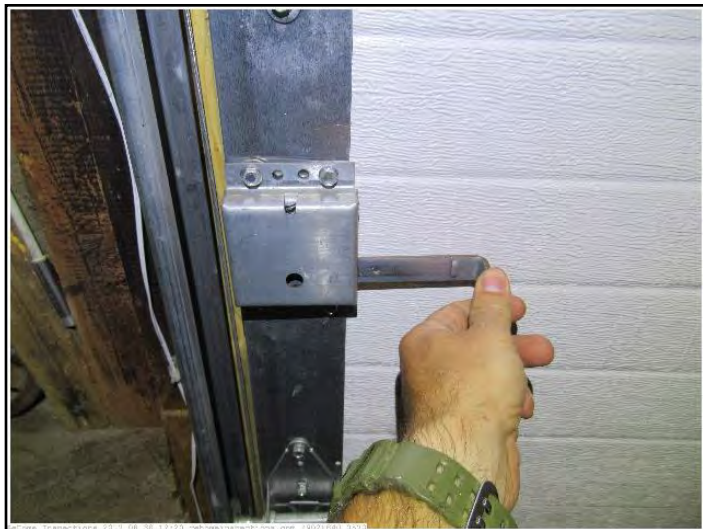
recommend to remove lock
