Home Inspection Report

FOR THE PROPERTY AT:
123 Sample St
Mocktown, NS

INSPECTION DATE:
Saturday, December 24, 2016

RE: Report No. 1135, v.0
123 Sample St
Mocktown, NS

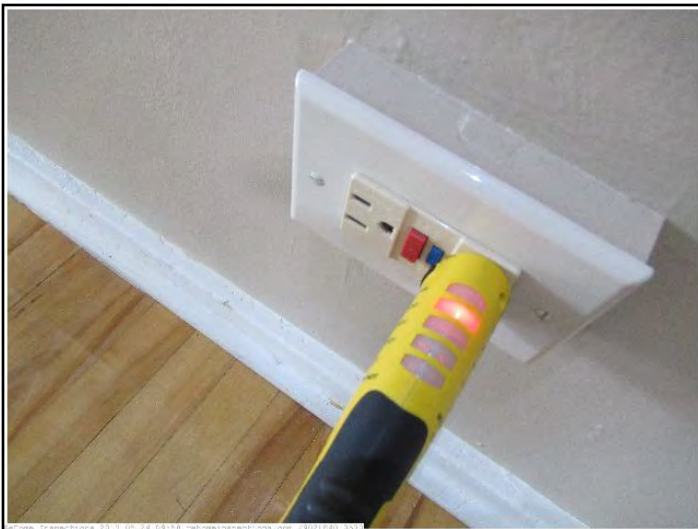
upgraded to GFCI - okay

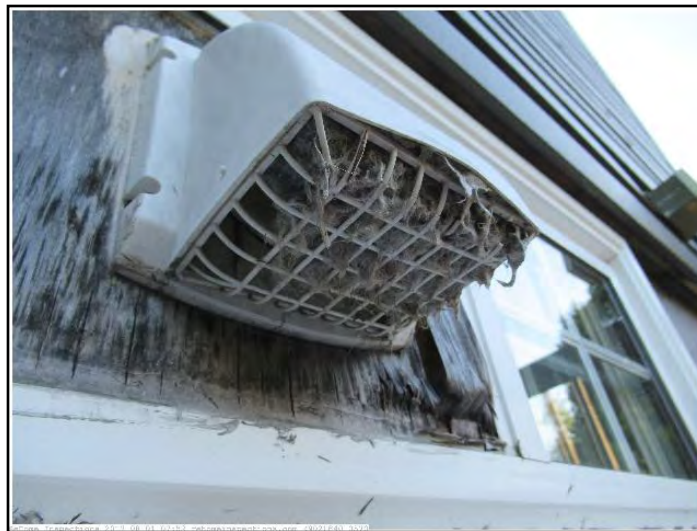
dryer vent screened
