Home Inspection Report

FOR THE PROPERTY AT:
123 Sample St
Mocktown, NS

INSPECTION DATE:
Saturday, December 24, 2016

RE: Report No. 1135, v.0
123 Sample St
Mocktown, NS

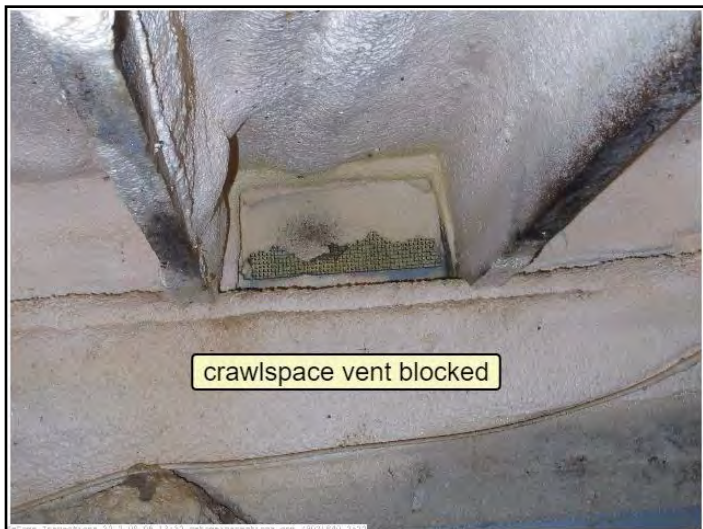
crawlspace vent blocked

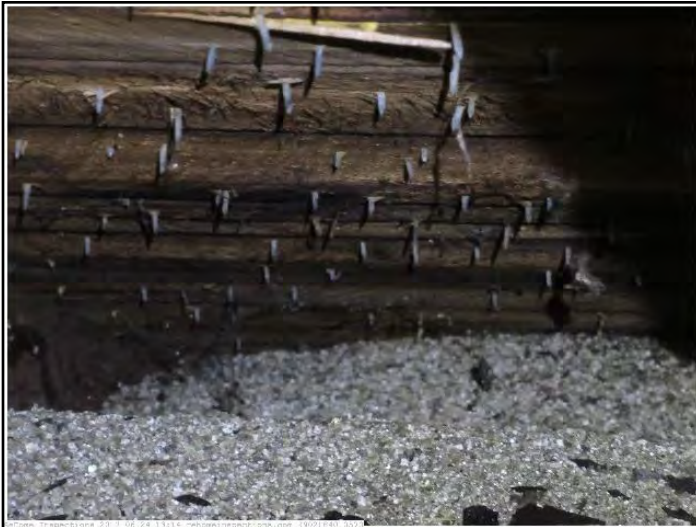
vermiculite

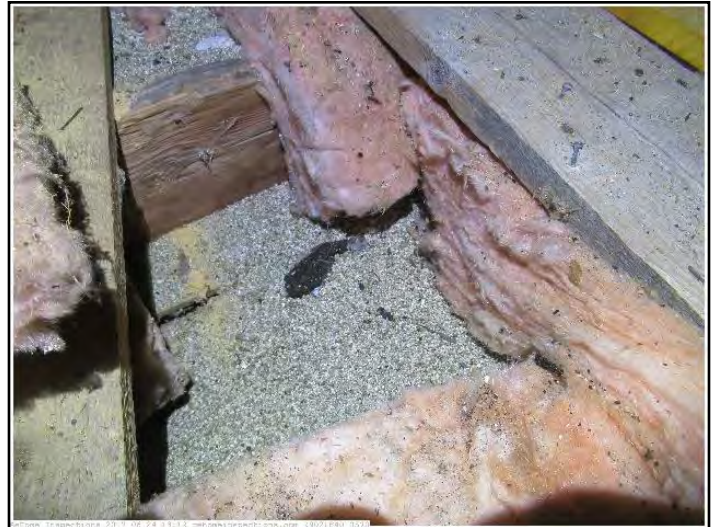
vermiculite
